FREETHY DAM

NDI ID NO. PA-00171 DER ID NO. 64-160

PHASE I INSPECTION REPORT

NATIONAL DAM INSPECTION PROGRAM

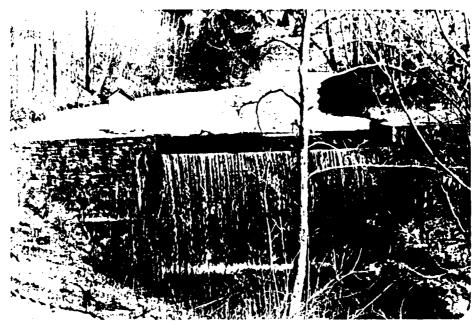
A. Dam and Reservoir.

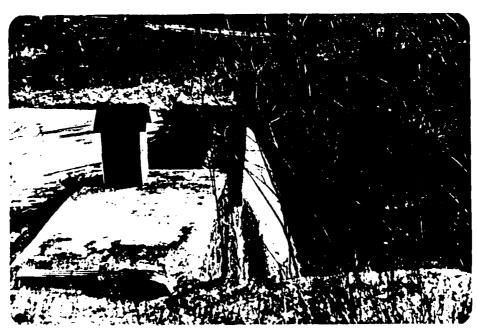
- b. Dam. Overall, the dam is in good condition. There are a few stones missing from the downstream face. Clear seepage was observed at the right abutment contact approximately 15 feet below the top of the dam. The flow was estimated at 30 gallons per minute (gpm.). Red shale was observed at the right abutment, just above and below the elevation of the top of the dam. Gray shale outcrops about halfway down at the right abutment and about 6 feet below the top of dam at the left abutment. The concrete cap is in good condition. It varies from 3 inches to 6 inches thick on the downstream edge. Most of the concrete facing on the upstream face was submerged and could not be observed. The portion of it above the water level, however, was in good condition.

B. Dan - From Right Abutment.

- a. The following studies and remedial measures, listed in approximate order of priority, are recommended to be undertaken by the Owner without delay:
- (1) Perform additional studies to more accurately ascertain the spillway capacity required for Freethy Dam as well as the nature and extent of measures required to provide adequate spillway capacity. Take appropriate action as required.
- (2) As part of the studies under (1), a structural stability analysis of the dam should be made. Take appropriate action as required.
- (3) Perform a detailed inspection of the 30-inch diameter outlet pipe. Take appropriate action as required.
- (4) Visually monitor the seepage at the right abutment of the dam. If the condition worsens, take appropriate action as required.
- (5) Replace the stones missing from the downstream face of the dam.

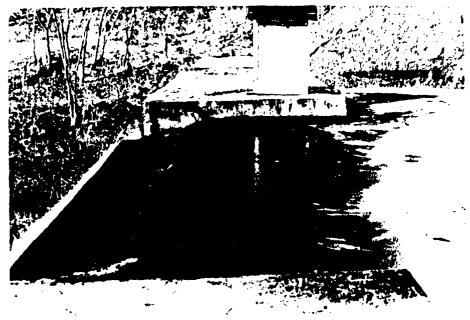
C. Spillway - Looking Toward Right End of Dam.
